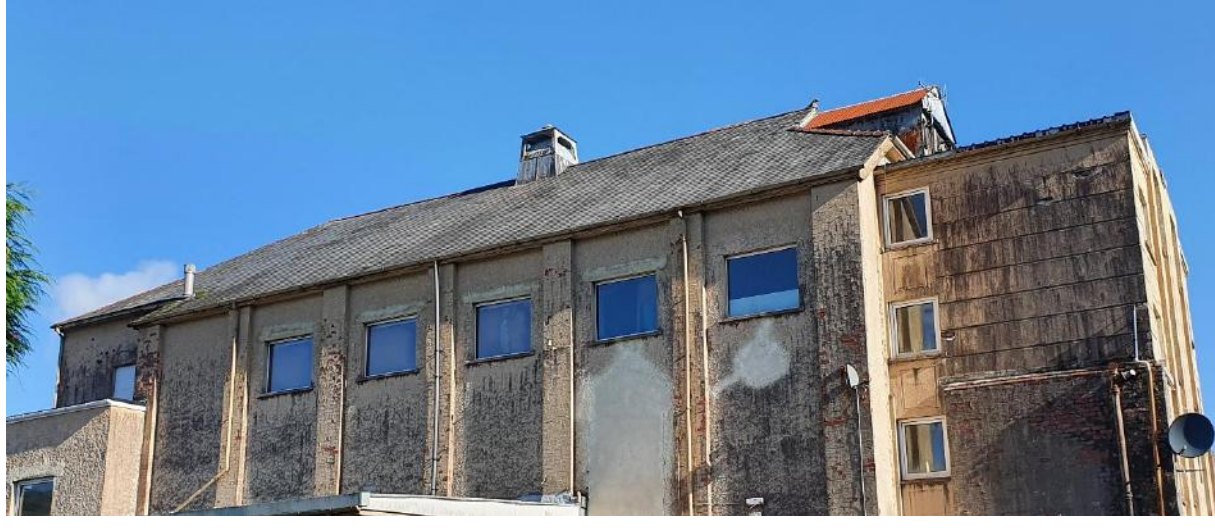
Little could be seen from ground level of the main roof structure. There is a cupola on the ridge midway along the roof. The condition of this could not be determined. There is a corrugated sheet steel roof section on the south side front elevation covering the dormer portion of the roof. This appears to have corroded however the full extent could not be determined from ground level.

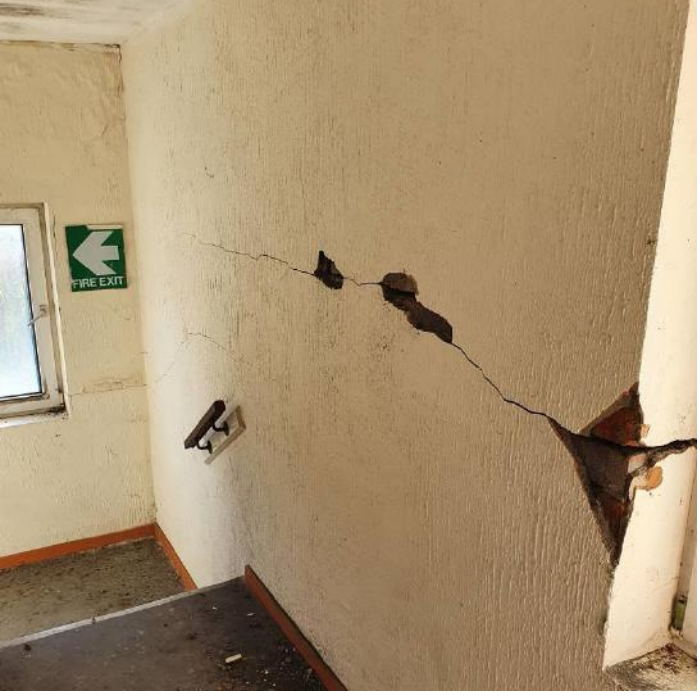
Front Left Stairwell
Severe damp penetration visible at the landing to level 2 on west wall and around the window opening.
At gallery level horizontal crack damage was noted.

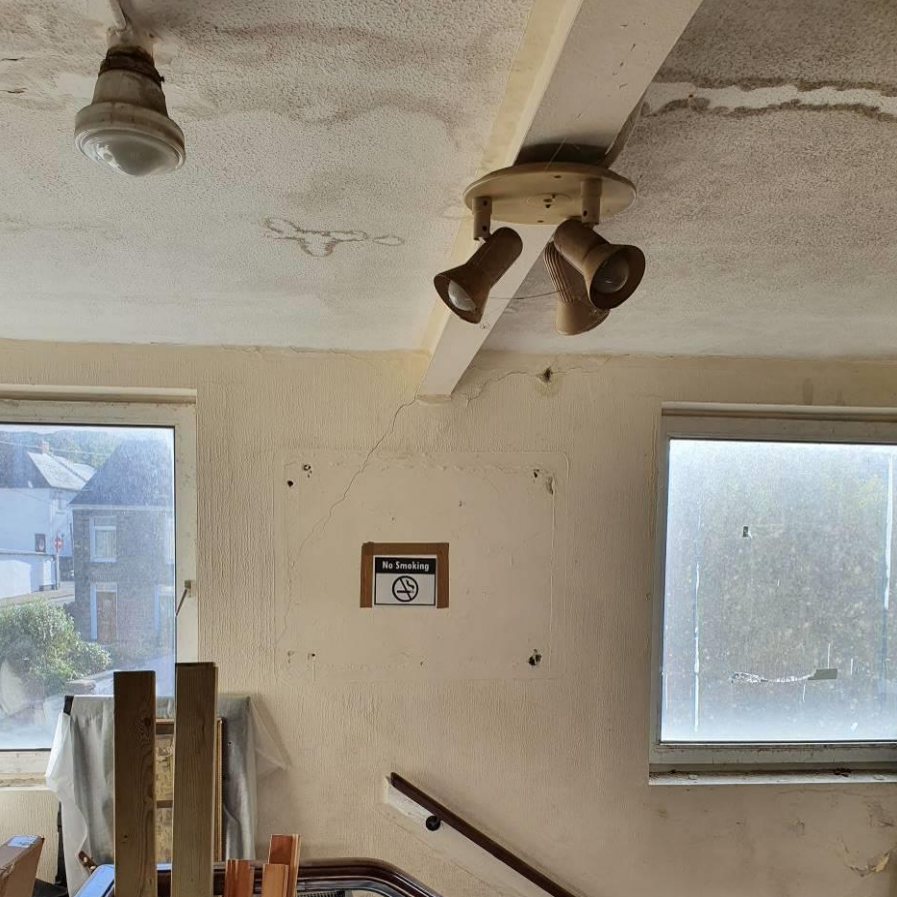
Front Left Stairwell
At first floor level a single 203UB section spans to the front wall and supports a section of the floor slab above. No evidence of corrosion was noted to the steelwork. The steel does not appear to have any fire protection. Diagonal cracking is visible on the inner leaf of the front wall where the steel is bearing on it. On the internal west wall face at ceiling level horizontal crack damage was noted running the full length of the wall.
Damp is also present on walls and ceiling.

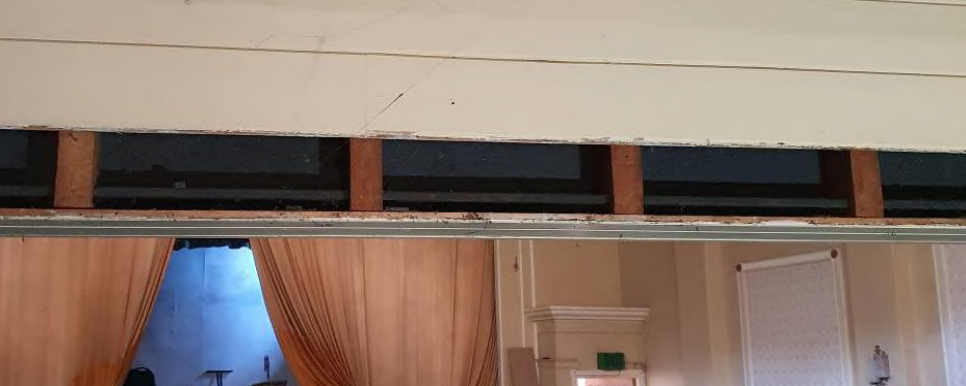
Theatre
The walls appear to have some superficial crack damage and there is evidence of damp on some wall projections.
There is evidence of water damage to the ceiling within the theatre space.
The encasement to the steelwork appears to have been disturbed and are no longer afforded the required level of fire protection. Similarly, the circular hollow sections supporting the RSJs do not appear to have any fire protection.

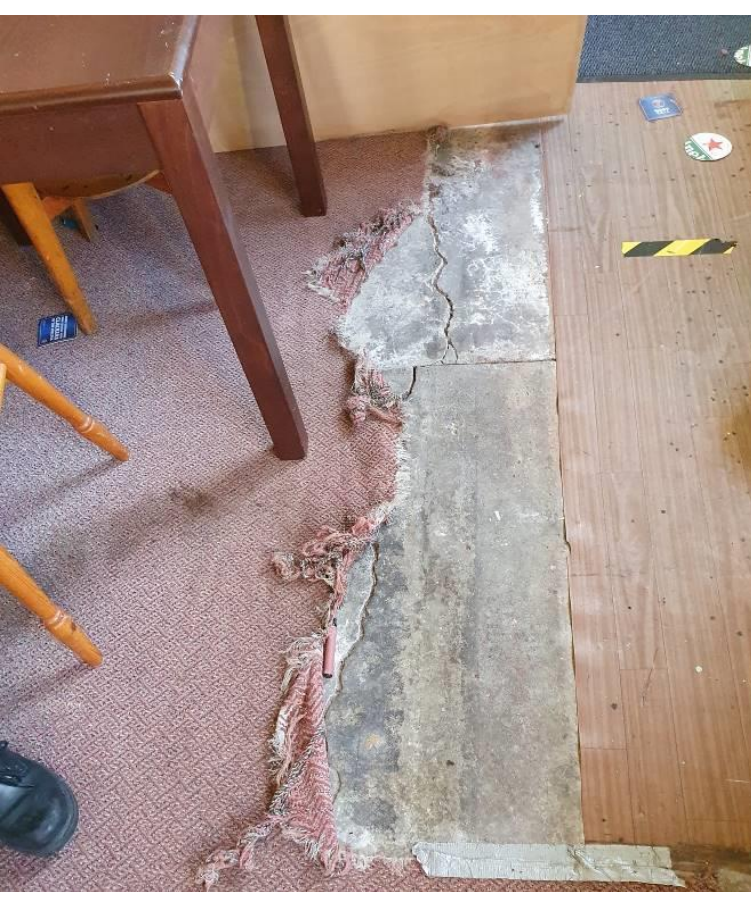
Snooker Room
The ground bearing slab appears to have a continuous crack of 6-8mm running north-south through the length of the room. This has caused a fall of approximately 25mm from the high point of the crack toward the west wall.
Signs of damp can be seen in several areas around the room including on the rear elevation wall and ceiling.
Crack damage was visible above timber / concrete lintels above the fire escape door, and the window and doorway to the original external wall.

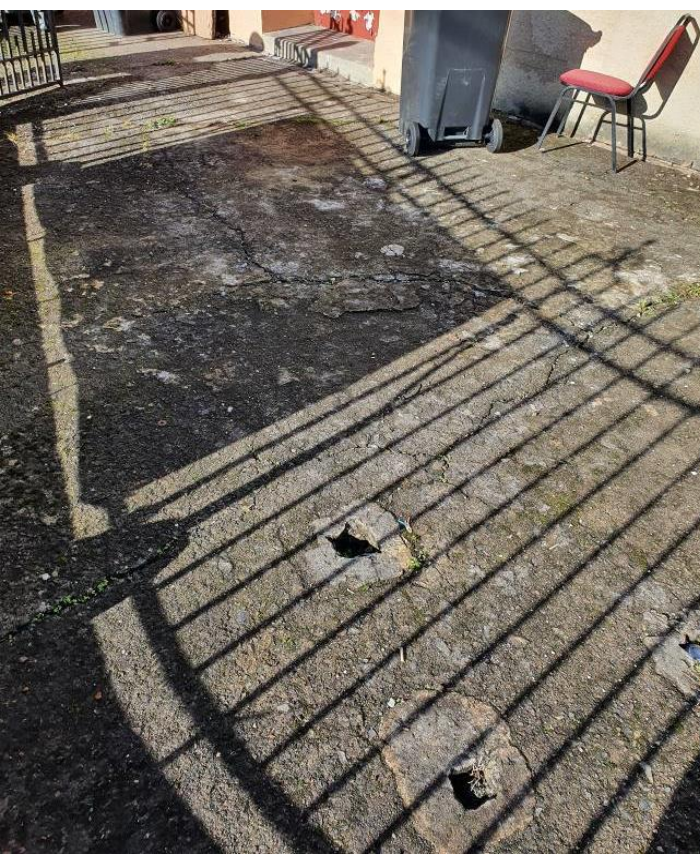
A concrete slab providing access to the building from the pavement is in poor condition with cracking, scarring and evidence of historic canopy structures still present. Vegetation is growing in the crack damage. A shallow surface drainage channel runs adjacent to the external leaf of a gutter and manhole to the east of the site. The condition of the drainage system could not be inspected.

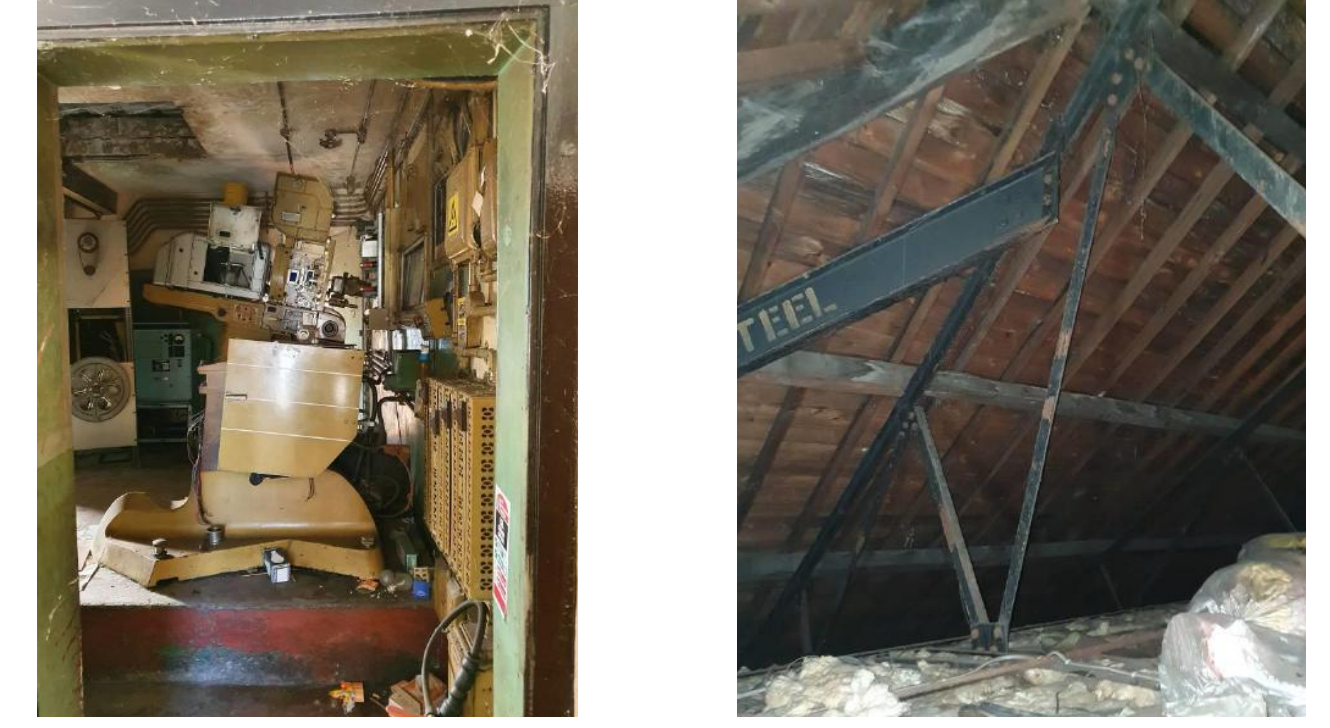
Attic
A head and shoulders visual inspection was undertaken from the attic hatch with the attic space appearing to be dry. The timber structural members appeared to be dry with no evidence of rot, there was evidence of local areas of damp on the timber sheathing to the roof.
Some surface corrosion was noted to the steelwork however the sections are generally in good condition with no loss of section being evident. The north side of the attic could not be inspected.

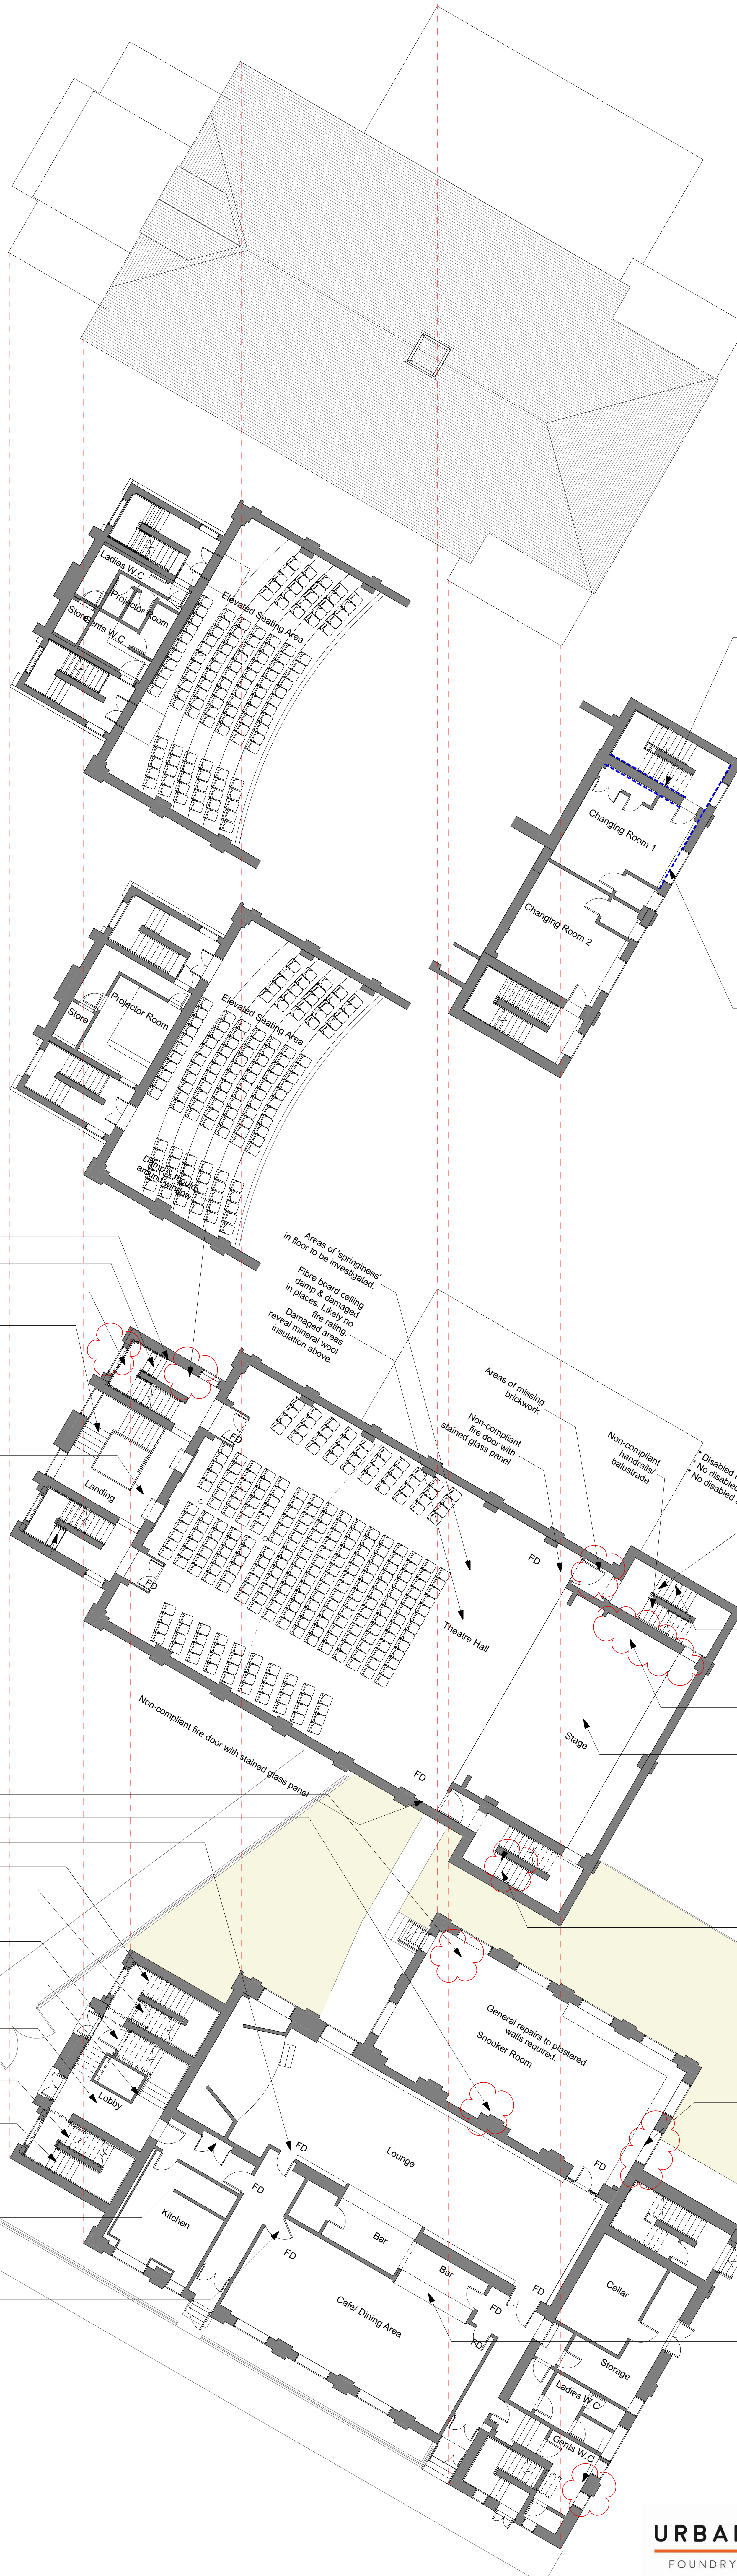
There is some ventilation ducting in the centre of the attic which is otherwise empty.
The front hipped / dormer section of roof has an access door on to a small flat roof area which could not be inspected. The flat roof is situated over the projection room. The door is in poor condition and could allow water ingress.
