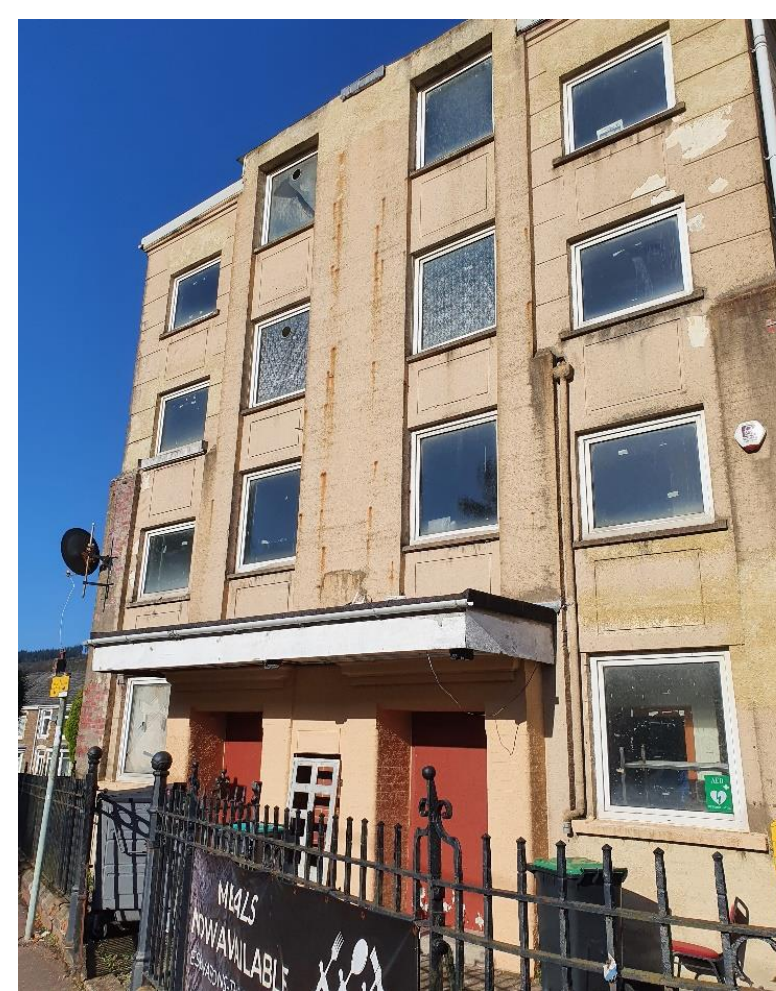
Front Elevation

The front face of the building has a total of 14 windows with original lintels in situ. Internal cracking at first floor level and gallery level does not appear to have propagated through the outer leaf. Spalling render was noted towards the top right hand corner of the front face and at the lower projections where the brickwork is exposed. Rust colored staining was also evident to the central area of the front elevation. This may suggest the cavity wall ties are suffering from corrosion. (may also be fixings for historic signage?)

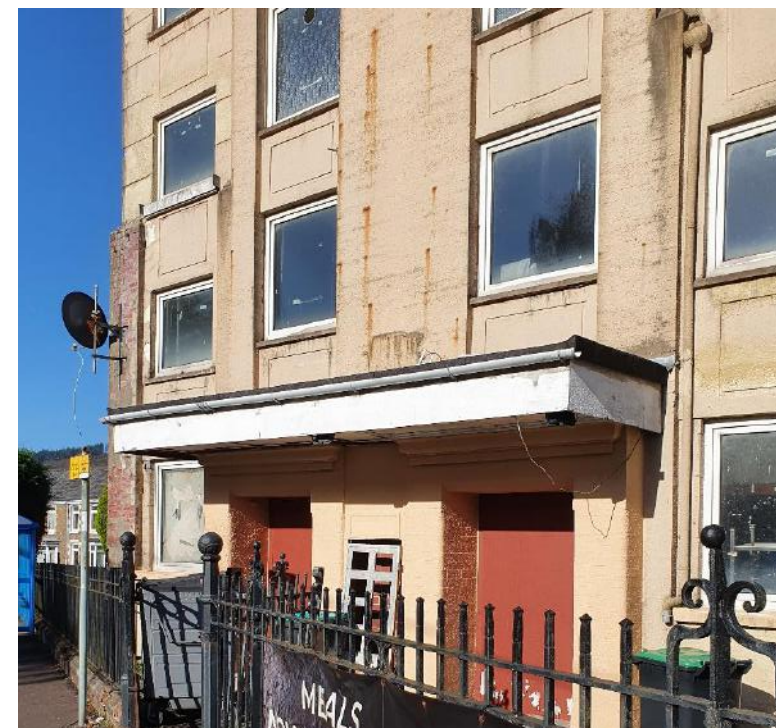
The canopy structure to the front elevation is clad in timber and the structural elements cannot be seen. The corner of a lead detail is visible from ground level however the top of the canopy was only visible from inside the building preventing a detailed inspection. The canopy has a felt covering sloping toward a front gutter channel. There is no downpipe to collect and direct surface water runoff to the drainage system.

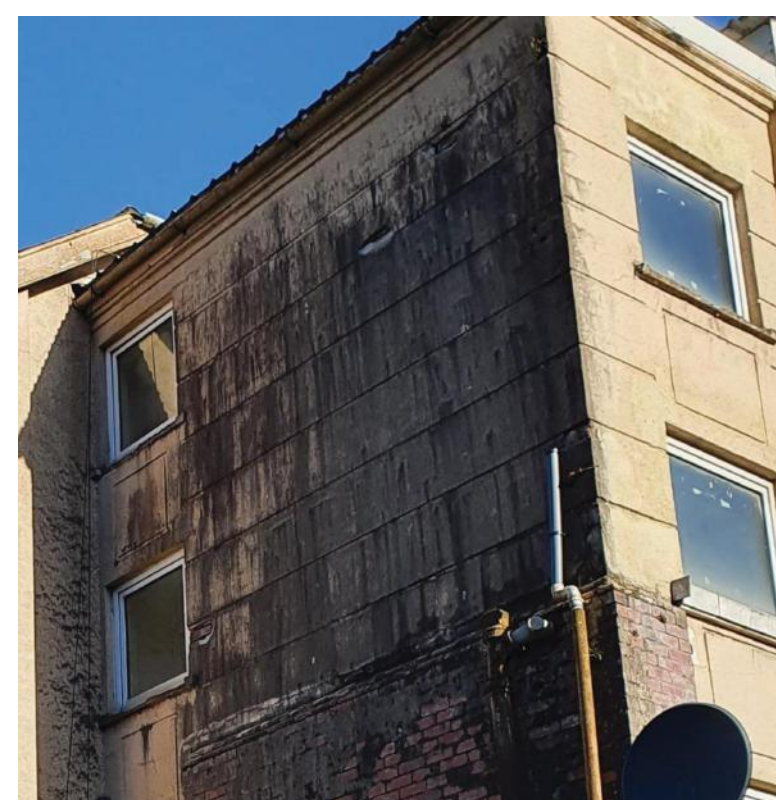
Left Elevation

Spalling render was visible on south side of upper levels of the front left stairwell where the brickwork has become exposed. Rain water goods are generally missing in this area leading to the deterioration of the mortar beds, the mortar has become friable and perished. Some spalling of the concrete window sills was visible. See photograph 3

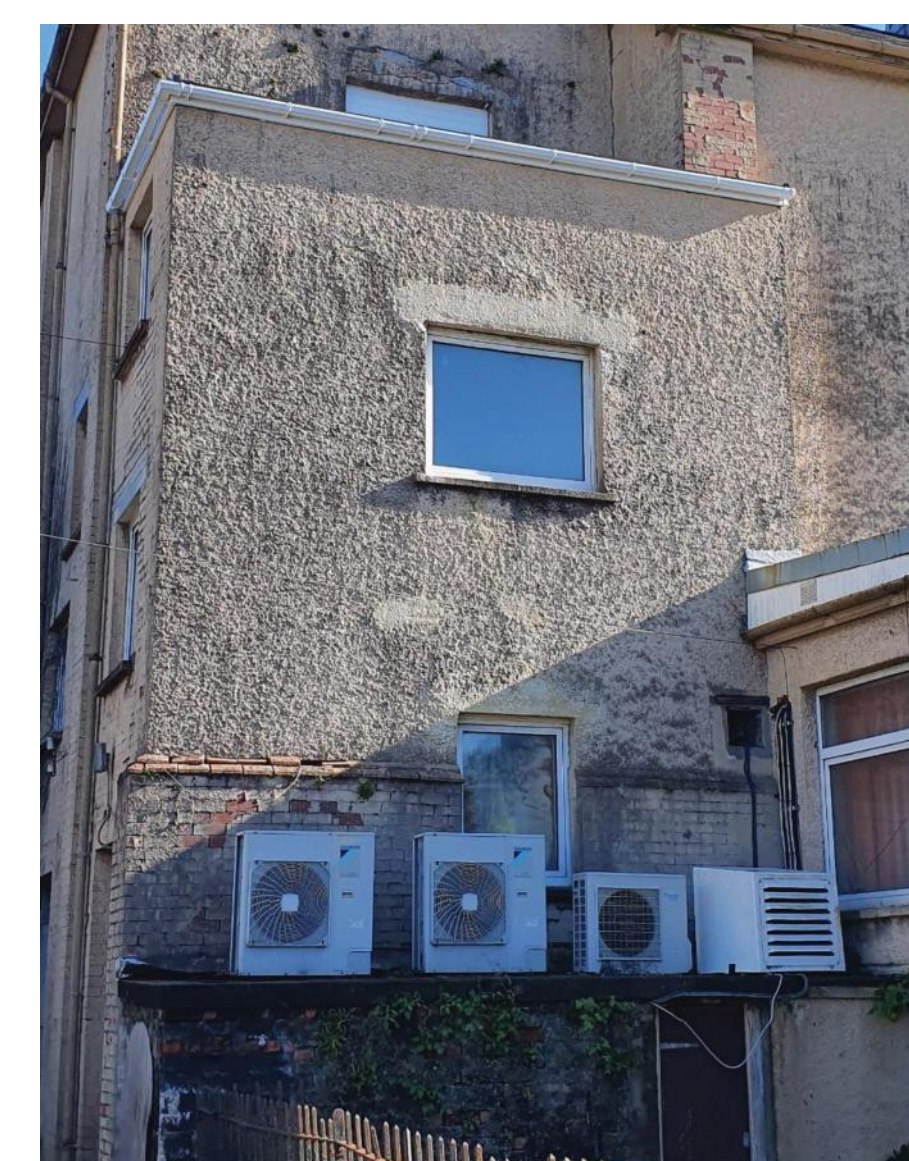
The external wall construction to the vertical extension housing the access stairs appears to be of a narrower construction compared to the original wall below. The flashing detail between these different constructions appears to be in disrepair.

Horizontal and diagonal crack damage was noted around a lintel to the northwest corner of the upper level. A more detailed inspection on the condition of the lintel is required. The roof gutter is missing at this location.

The cellar wall projection left of the rear left stairwell has cracking at the eaves level and vegetation growing between brick courses. There are no rain water goods for this structure. The lead flashing detail between the main wall and the flat roof of the enclosure is in poor condition.

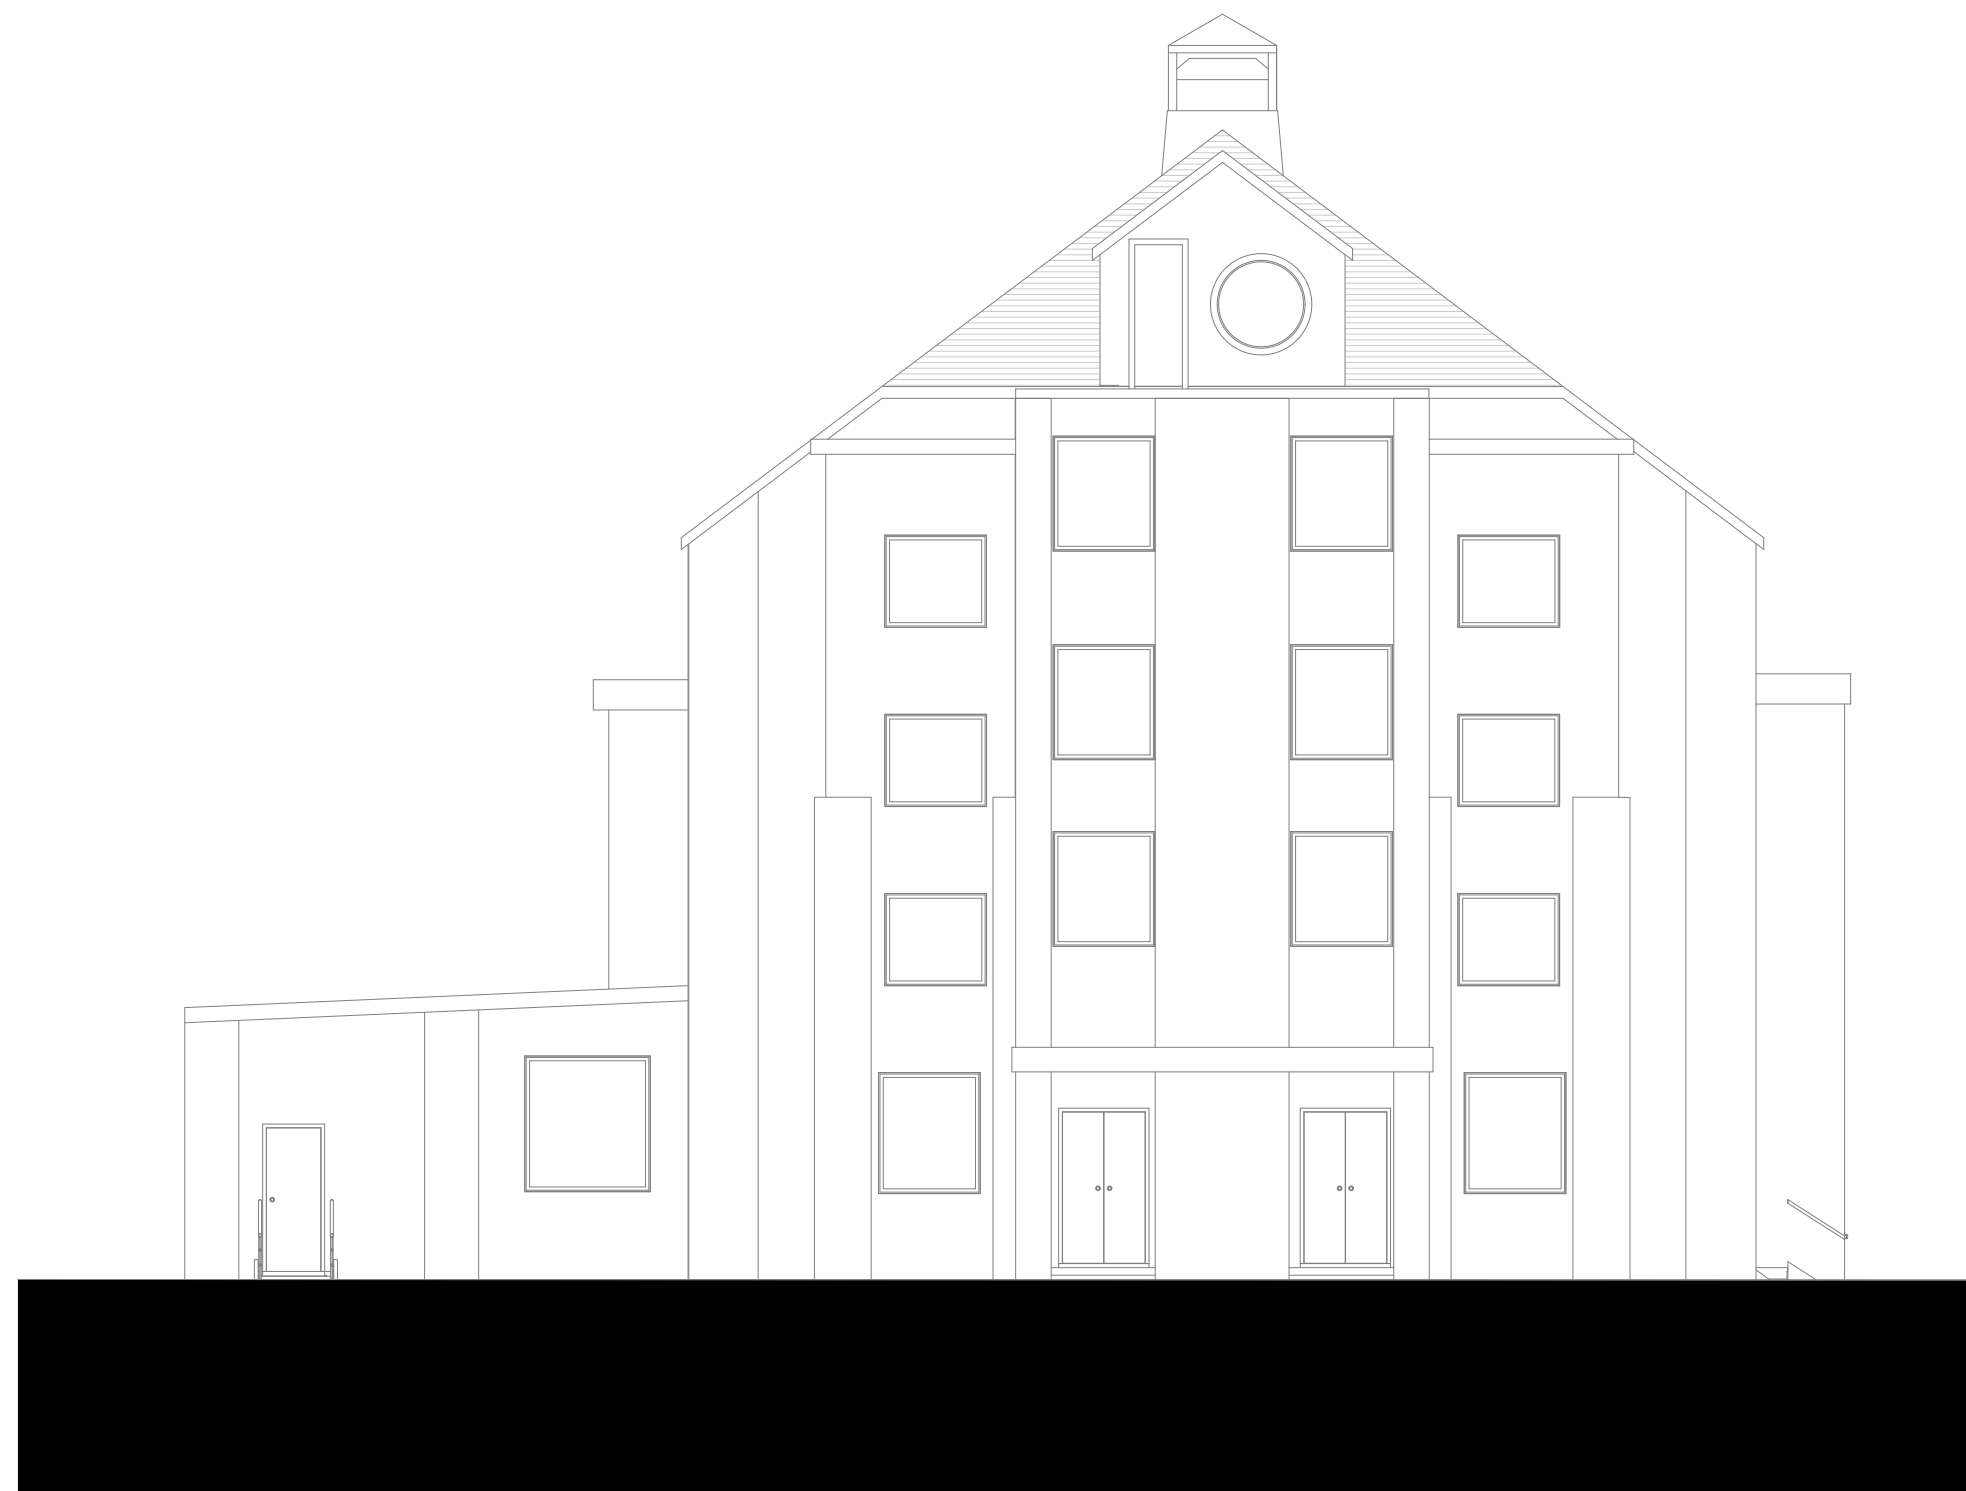
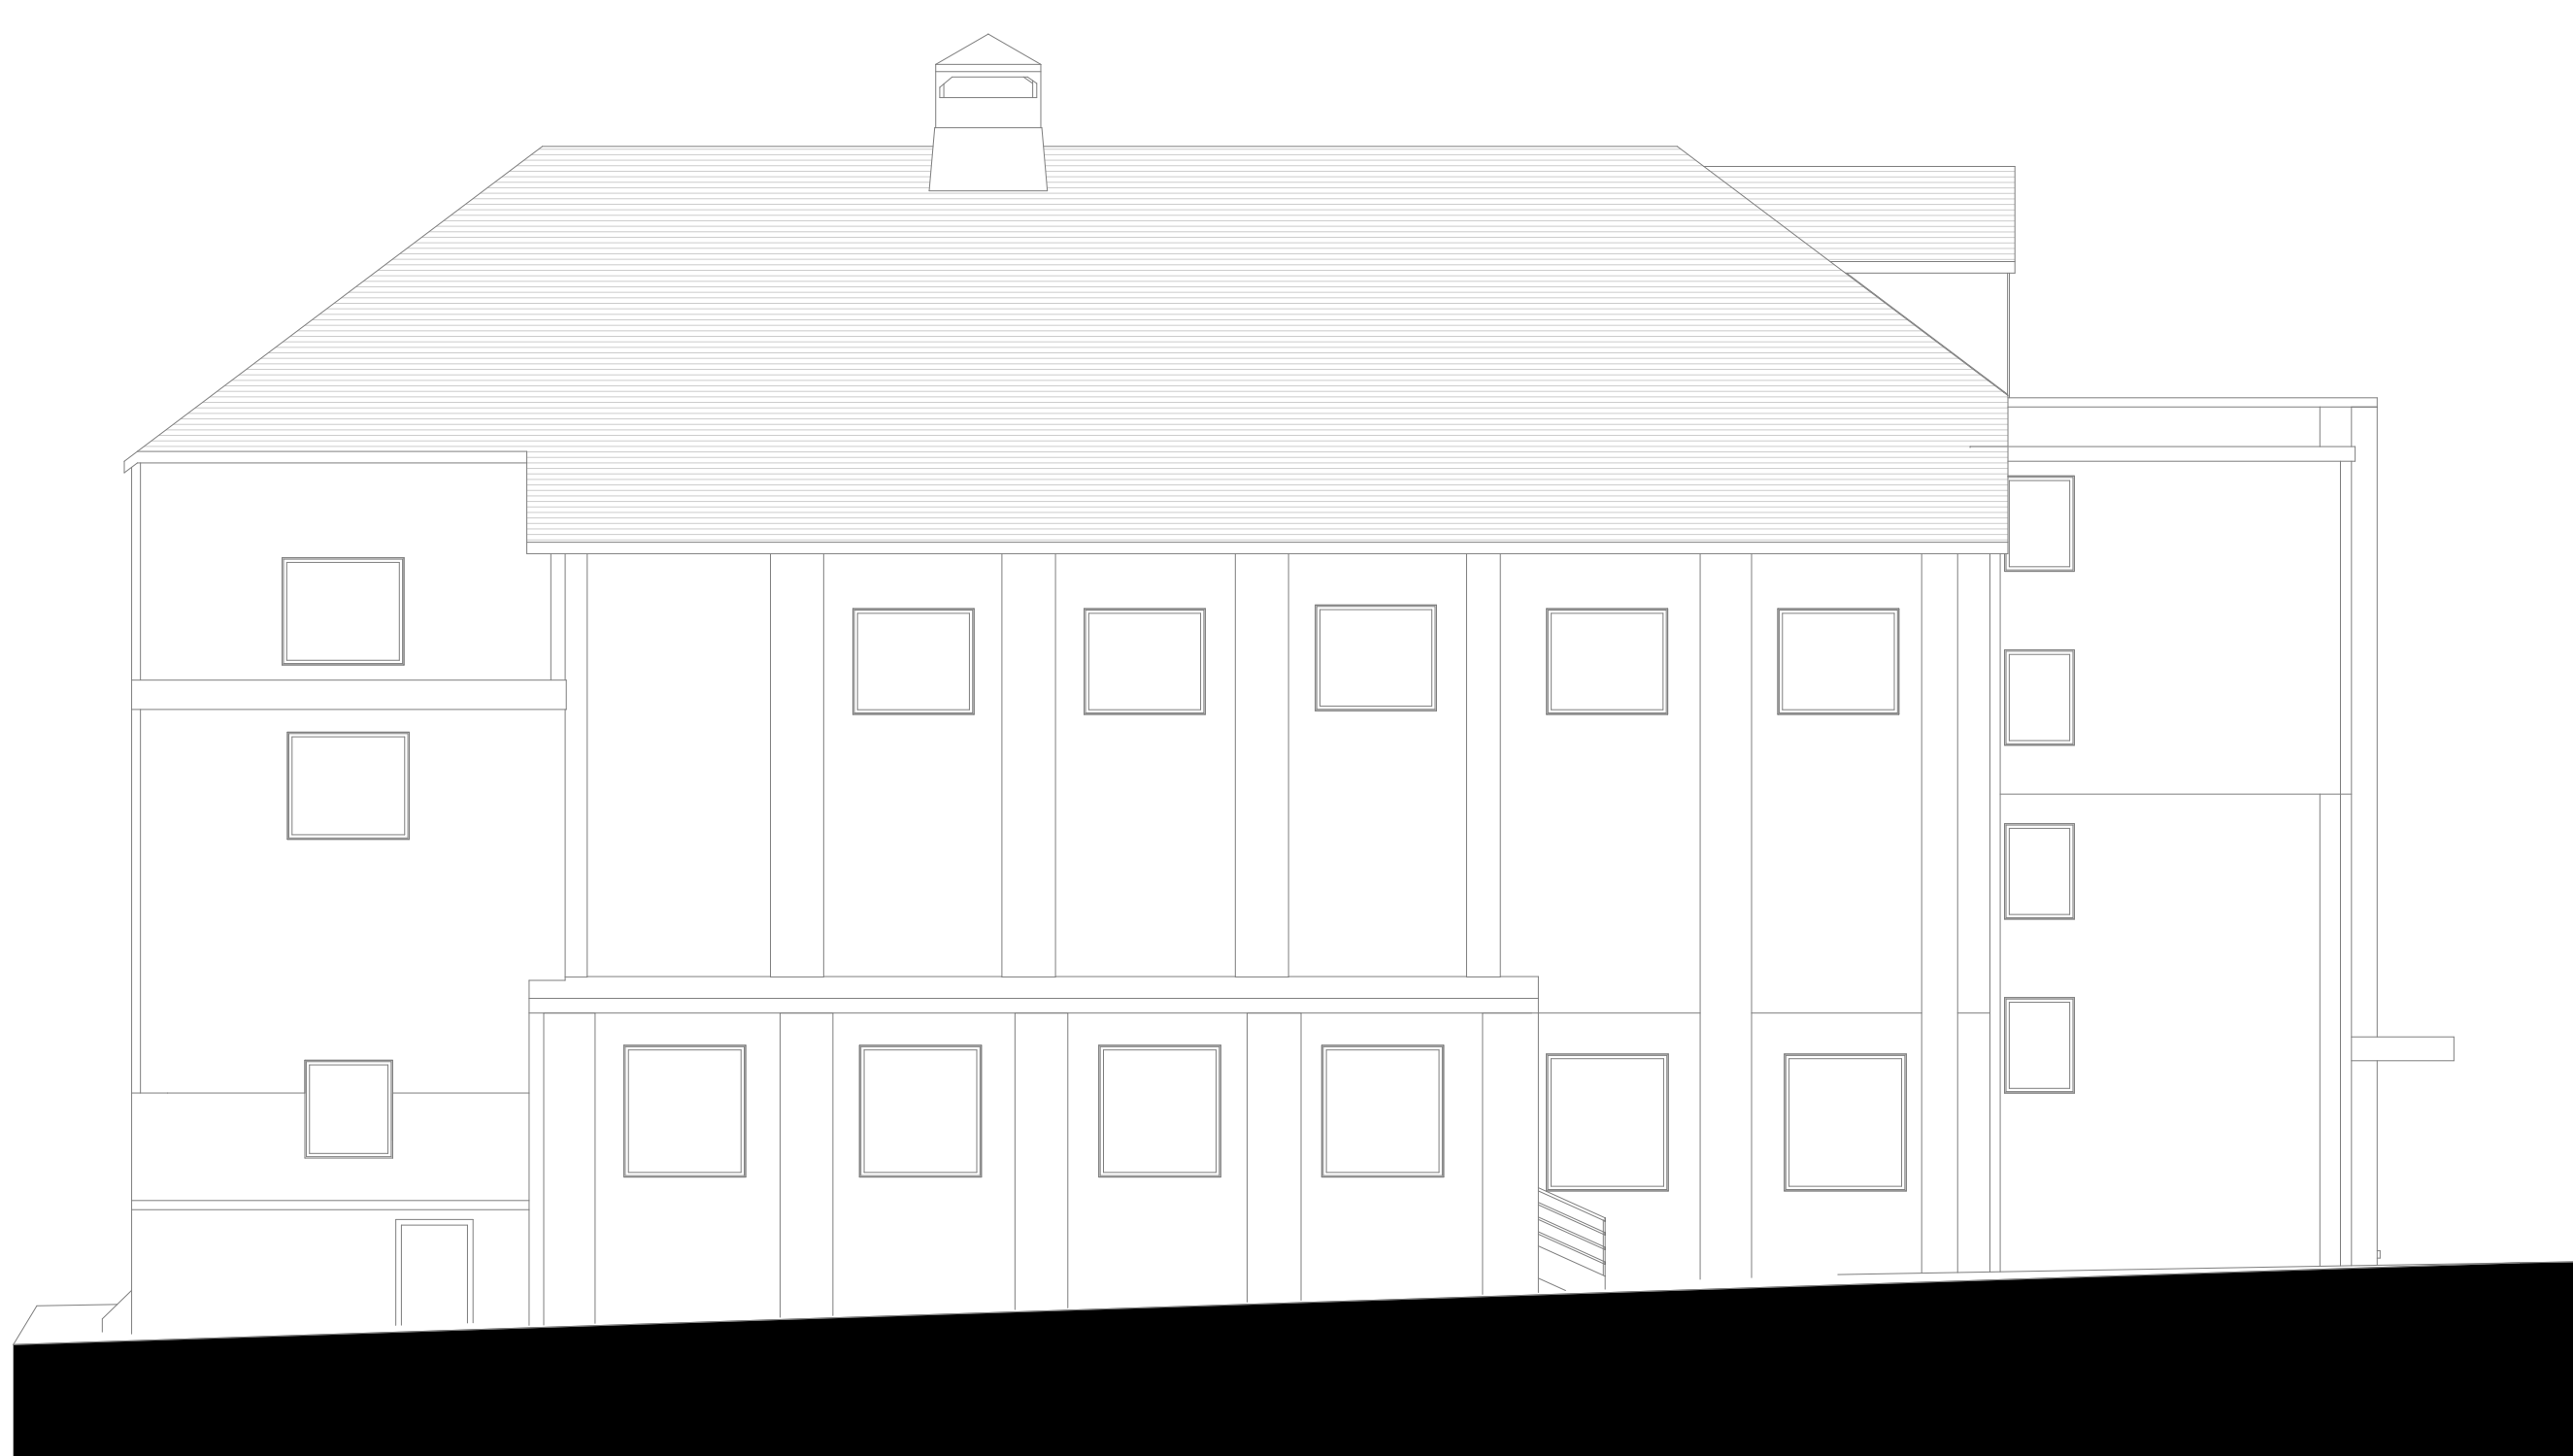
Rear Elevation

Ivy growth was noted to sections of this external elevation, the ivy appears to have been treated with some form of herbicide. The mortar beds to the external brickwork may have been impacted historically by the vegetation causing the mortar to perish locally.

The soil stack vent pipe to this elevation is damaged. Rainwater goods are in reasonable condition however some sagging of the gutters was noted.

A window opening has been partially blocked up however the cavity is visible at the head.

Horizontal crack damage was noted to the lintel over the cellar doorway.

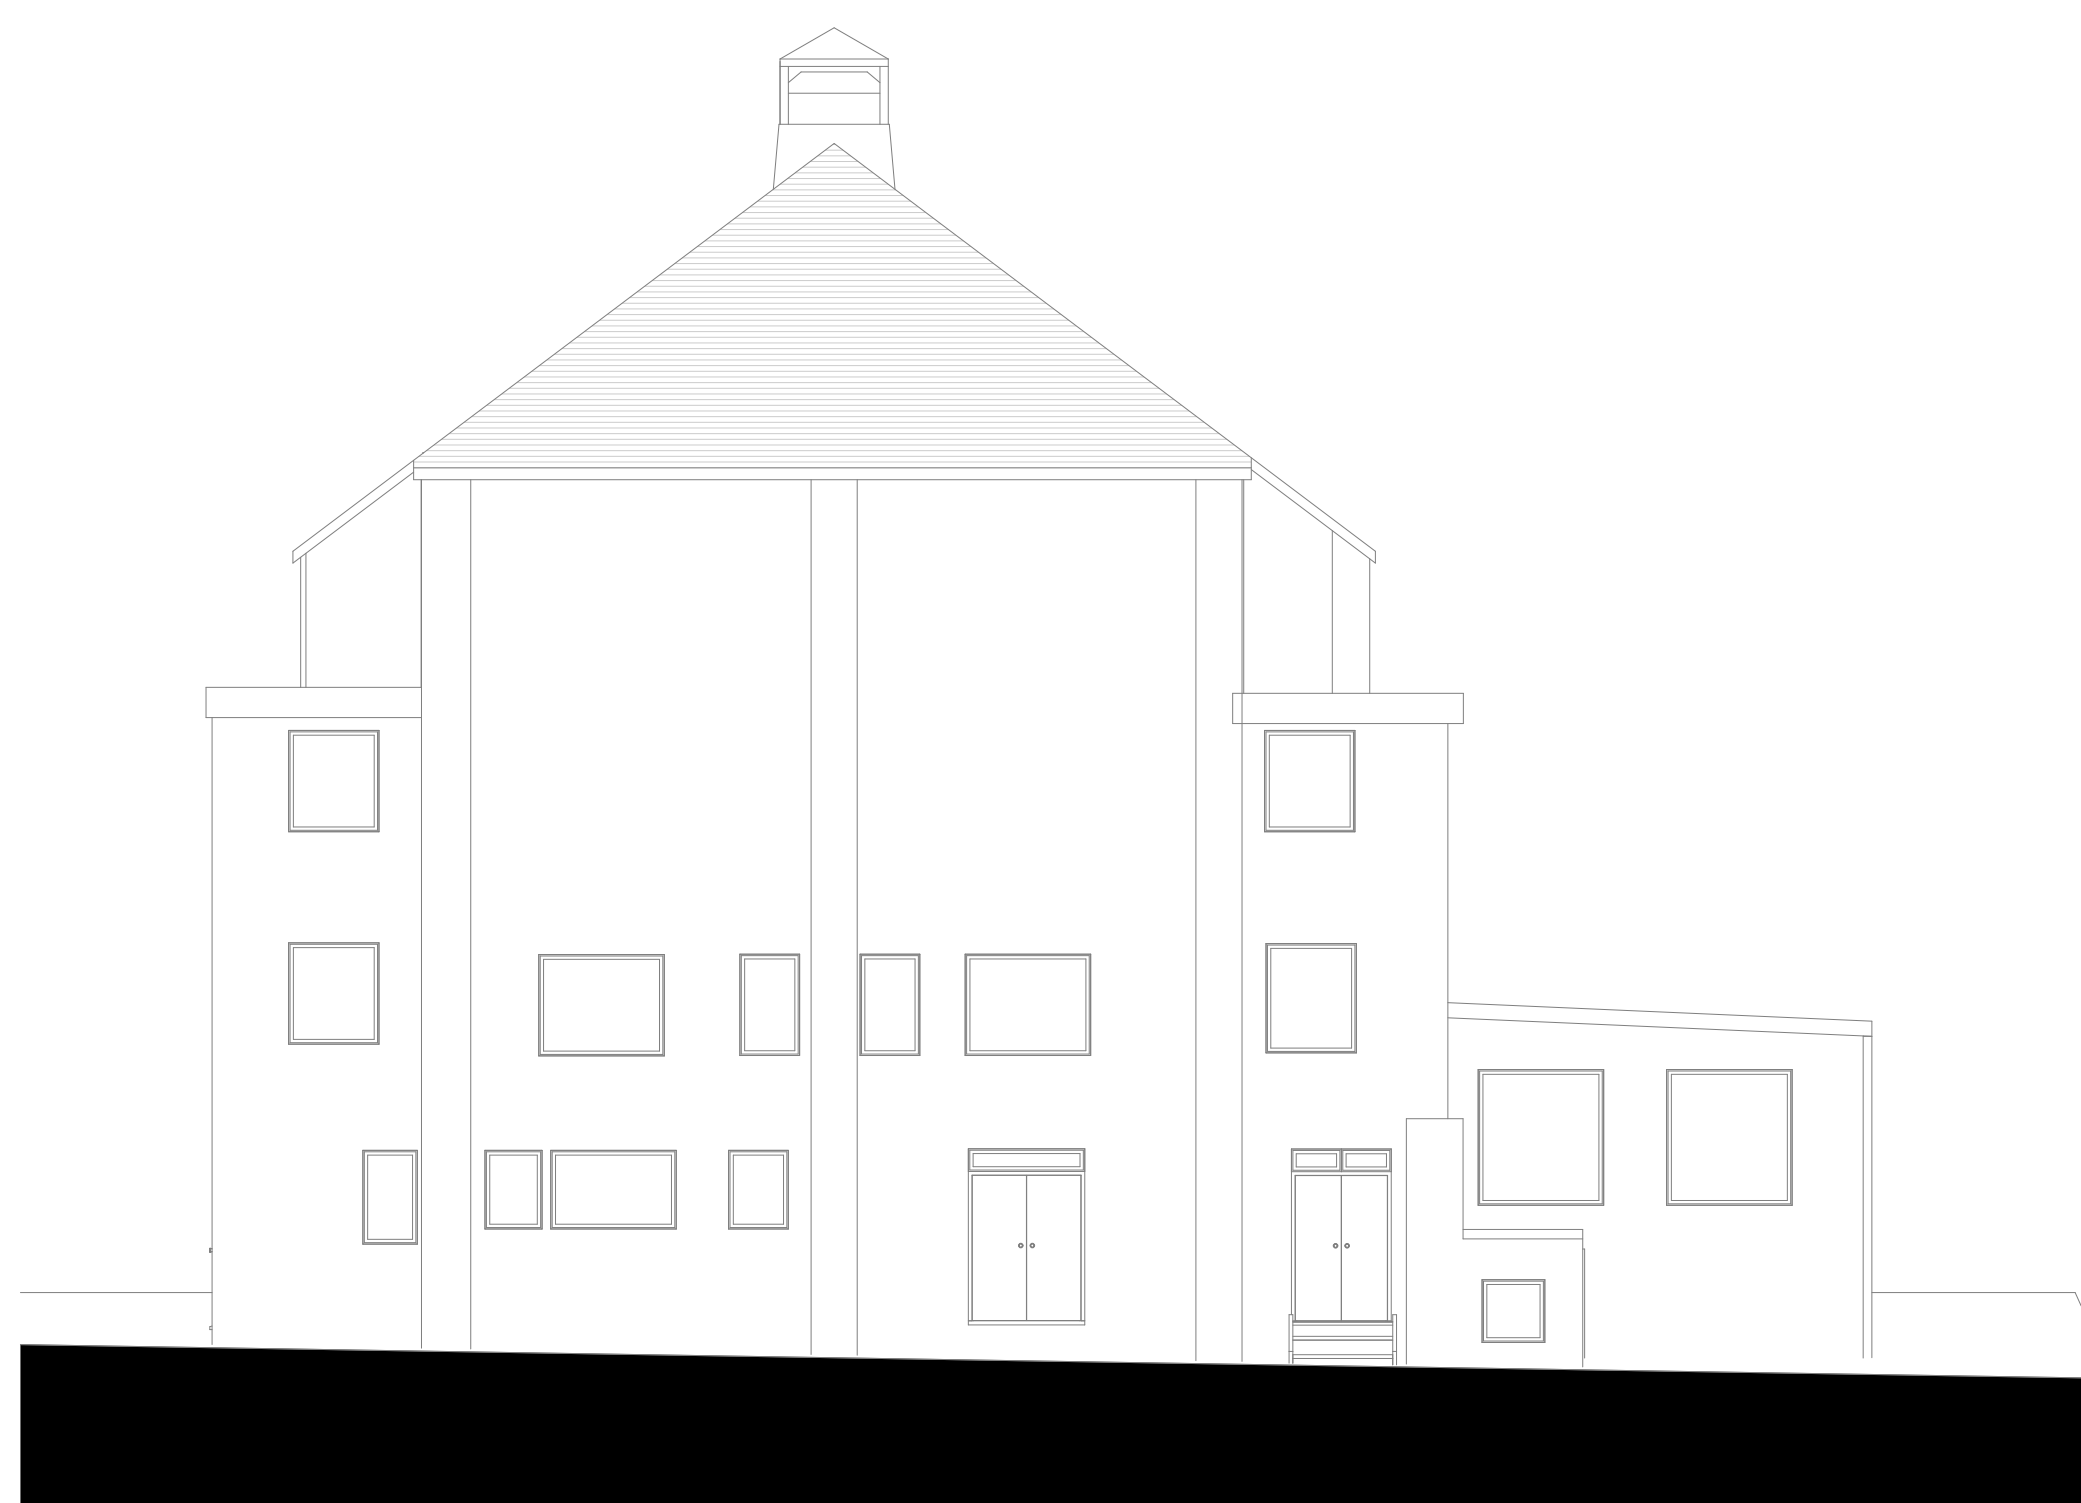
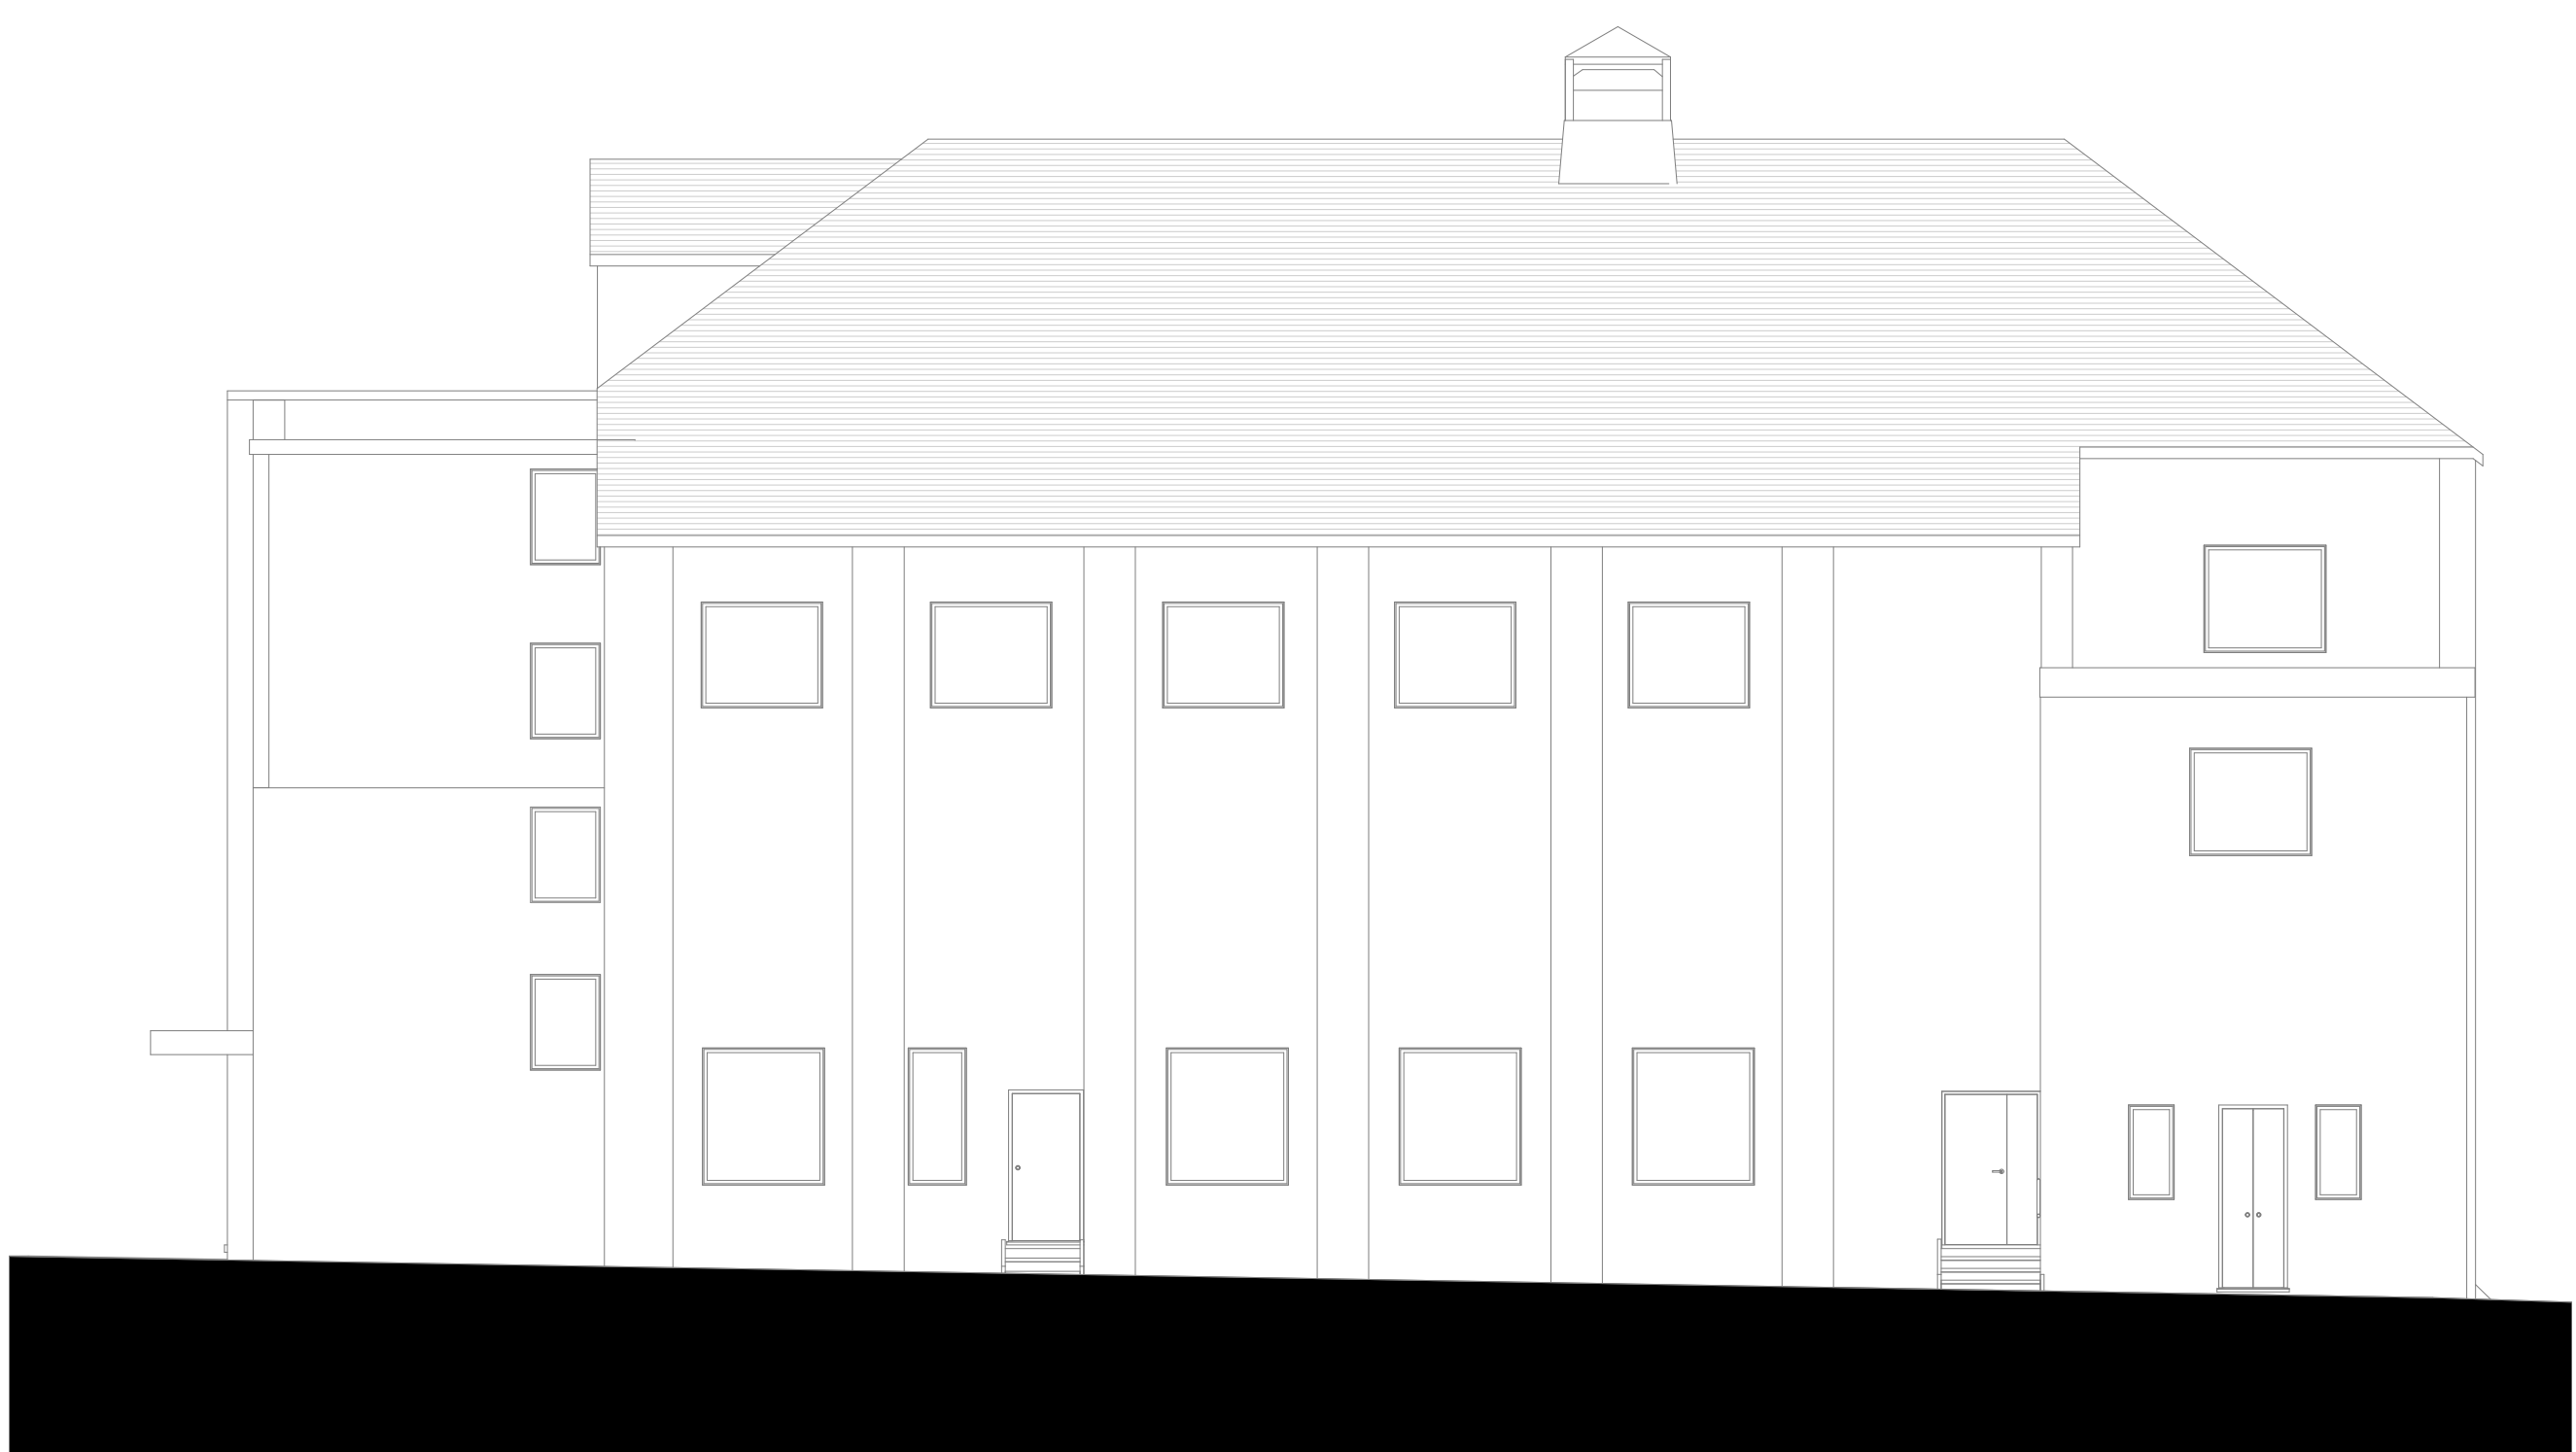
Right Elevation

Spalling concrete was noted on some window sills.

Vegetation growth was noted to the wall near the side access doorway.

Crack damage was noted at eaves level to the front and rear corners above the lintels, the lintels that appear to have been replaced at some time in the past. A beehive or wasps nest was visible at time of inspection behind the fascia of the southeast eaves corner.
